**Flood Control Project Maintenance
Levee Inspections**

Maintenance Issue Types Only, Levee Inspection Report By Mile - Spring 2019

Sutter Maintenance Yard Maintenance Area 0005

Waterway	Bank	Unit Miles	Inspection Start/End	Inspector
Unit No. 01 Butte Creek	Left	15.08	05/14/2019 05/14/2019	Makar Sokol

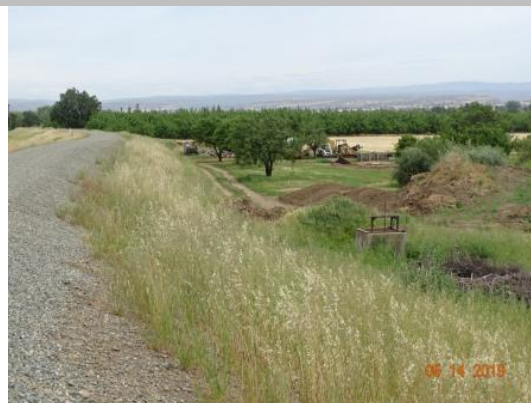
Photo 1 of 1 : SP_2019_MA0005_196_74_20190520_00089.jpg

View of the vegetation on the landside slope. Spring 2019.

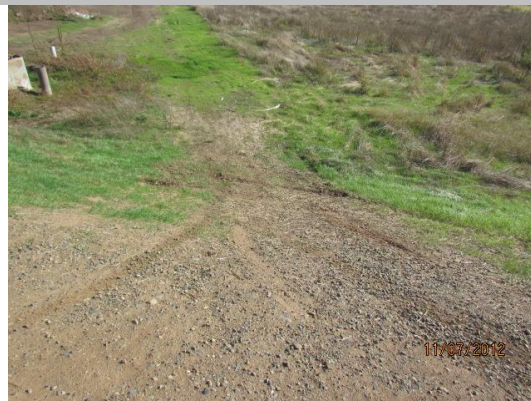
Photo 1 of 1 : SP_2019_MA0005_196_9_20190327_00004.jpg

View of the vehicle erosion along the landside slope.

LM Start	2.54	Rating **	M	Issue No.	9
LM End	2.54	Issue Type +	Ma	Location *	LS
Category	Earthen Levee			GPS Latitude/Longitude	
				Start	End
Item	Slope Stability			39.663876 °	39.663876 °
				-121.784014 °	-121.784014 °
DWR ID	DWR_MA0005_01_f_2012_9				
Comment Code					
S3 : Repair the levee slope damaged by vehicle traffic and prevent access where possible.					
Inspector Comment

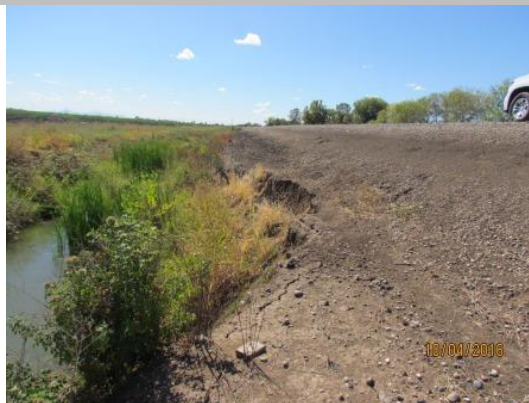
Photo 1 of 2 : SP_2019_MA0005_196_56_20190327_00029.jpg

View of the landside toe erosion.

LM Start	5.81	Rating **	U	Issue No.	56
LM End	5.81	Issue Type +	Ma	Location *	LS
Category	Earthen Levee			GPS Latitude/Longitude	
				Start	End
Item	Erosion / Bank Caving			39.621261 °	39.621261 °
				-121.773973 °	-121.773973 °
DWR ID	DWR_MA0005_01_f_2016_56				
Comment Code					
E2 : Schedule repair of erosion site prior to the next inspection.					
Inspector Comment

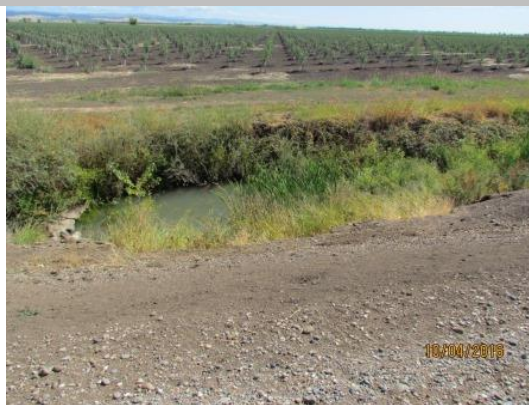
Photo 2 of 2 : SP_2019_MA0005_196_56_20190327_00030.jpg

Another view of the landside toe erosion.

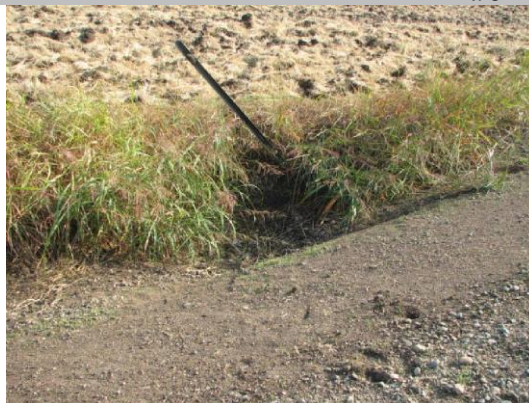
Photo 1 of 2 : UCIP_SP_2019_51970_67970.jpg

Comment Code						
Inspector Comment						
FS_ID:51970 DS_ID:1628 EP_NO: N/A Repair Type: Non-Urgent Crossing Status: Found UCIP Comments: 5/16/2017 LS inlet is almost completely buried. Nothing visible on the WS. Pipe has been selected to be internally cleaned and inspected as part of the DMP project. (DWR Sutter Yard-AFreitag)11/15/2016 Appears abandoned and should be done so properly. (DWR Sutter Yard-AFreitag)5/11/2016 Possibly an abandoned crossing. LS inlet was over 50% buried and nothing was found on the WS.8/4/2015 LS pipe end filled about 50% with soil and WS pipe end is buried.12/8/2014 Same as last inspection.6/11/2014 Same as last inspection.11/19/2013 Same as last inspection.5/29/2013 Same as last inspection.10/30/2012 Pipe filled with soil and outlet/appurtances are burried. FIELD_STRUCT_DESC: *ABANDONED* 24-inch corrugated metal drainage pipe through the levee, 8.5 feet below the crown. Flap gate on the waterside (WS). Concrete "U" shaped headwall on the landside (LS) toe. [Additional Reference(s): DWR Levee Log, 1990 (HLM 7.70). USACE Sacramento O&M Manual, Unit 515 - Upper Butte Creek - Part No. 1, April 1955, (Station 576+72), As-Built Drawing No. 50-4-2637, Exhibit B, Sheet 2, April 1950, (Station 576+72.4)]. FS Date: 5/31/2017 1:58:05 PM

Headwall at LS toe.

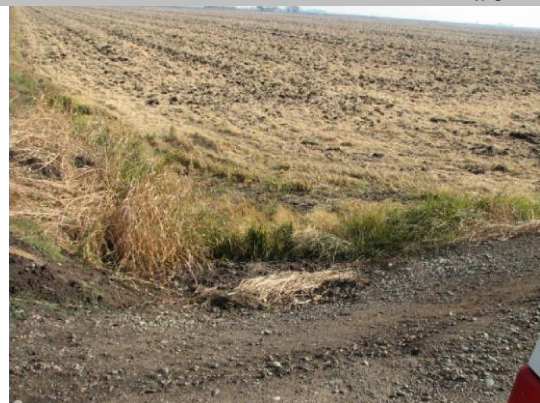
Photo 2 of 3 : UCIP_SP_2019_51972_67972.jpg

FS_ID:51972
DS_ID:1629
EP_NO: N/A
Repair Type: Non-Urgent
Crossing Status: Found
UCIP Comments: 5/16/2017 LS inlet is half blocked off by flash boards and sediment. WS flap gate is blocked closed by sediment. Pipe has been selected to be internally cleaned and inspected as part of the DMP project. (DWR Sutter Yard- A Freitag)11/15/2016 LS inlet was unburied and entire pipe is about 25% full of soil. WS flapgate was shut and partially buried. (DWR Sutter Yard- A Freitag)5/11/2016 WS flap gate was about 50% buried and LS was 100% buried. Appears to be an abandoned crossing.8/4/2015 WS flap gate is partially buried by soil and being overgrown with vegetation. LS pipe end was underwater and suspected to still be completely buried with soil.12/8/2014 Same as last inspection.6/11/2014 Same as last inspection.11/19/2013 Same as last inspection.5/29/2013 Same as last inspection.10/30/2012 Pipe filled with soil.

Buried inlet at LS toe.

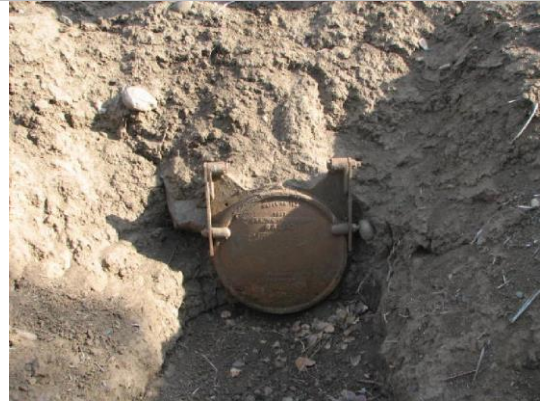
Photo 3 of 3 : UCIP_SP_2019_51972_67971.jpg

Comment Code						
Inspector Comment						
FS_ID:51972 DS_ID:1629 EP_NO: N/A Repair Type: Non-Urgent Crossing Status: Found UCIP Comments: 5/16/2017 LS inlet is half blocked off by flash boards and sediment. WS flap gate is blocked closed by sediment. Pipe has been selected to be internally cleaned and inspected as part of the DMP project. (DWR Sutter Yard- A Freitag)11/15/2016 LS inlet was unburied and entire pipe is about 25% full of soil. WS flapgate was shut and partially buried. (DWR Sutter Yard- A Freitag)5/11/2016 WS flap gate was about 50% buried and LS was 100% buried. Appears to be an abandoned crossing.8/4/2015 WS flap gate is partially buried by soil and being overgrown with vegetation. LS pipe end was underwater and suspected to still be completely buried with soil.12/8/2014 Same as last inspection.6/11/2014 Same as last inspection.11/19/2013 Same as last inspection.5/29/2013 Same as last inspection.10/30/2012 Pipe filled with soil. FIELD_STRUCT_DESC: 24-inch corrugated metal drainage pipe through the levee, 9.3 feet below the crown. Flap gate on the waterside (WS). Concrete headwalls at the landside (LS) and the WS toes. [Additional Reference(s): DWR Levee Log, 1990 (HLM 8.35). USACE Sacramento O&M Manual, Unit 515 - Upper Butte Creek - Part No. 1, April 1955, (Station 609+79), As-Built Drawing No. 50-4-2637, Exhibit B, Sheet 3, April 1950, (Station 609+78.5)]. FS Date: 5/31/2017 1:59:10 PM

Flap gate at WS toe.

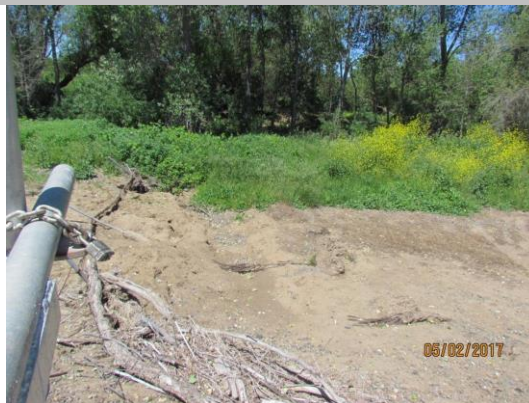
Photo 1 of 1 : SP_2019_MA0005_196_67_20190327_00032.jpg

View of erosion along the waterside slope.

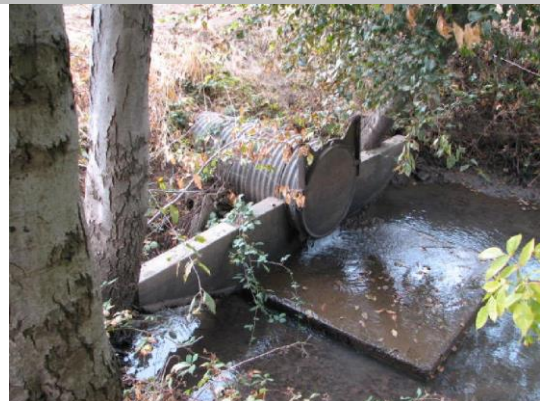
Photo 3 of 3 : UCIP_SP_2019_51999_68031.jpg

Wingwalls of headwall not supported by soil.

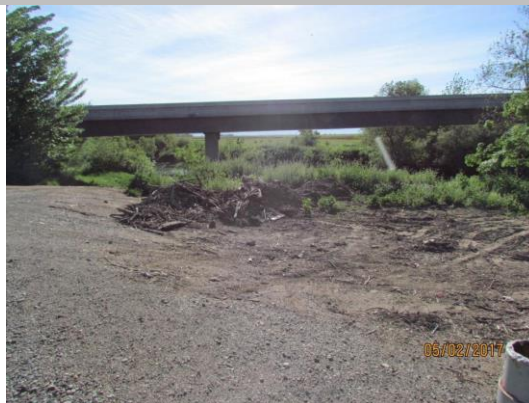
Photo 1 of 1 : SP_2019_MA0005_197_69_20190327_00037.jpg

View of the debris along the waterside toe.

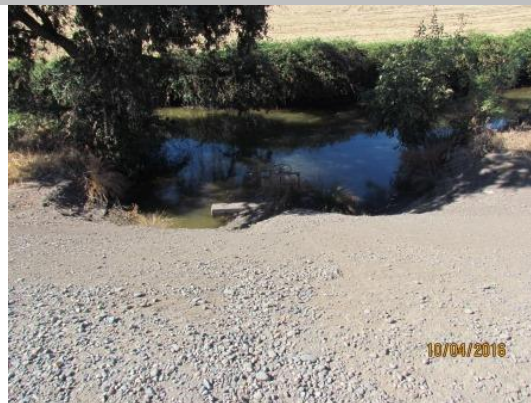
Photo 1 of 1 : SP_2019_MA0005_197_49_20190327_00024.jpg

View of the landside toe erosion.

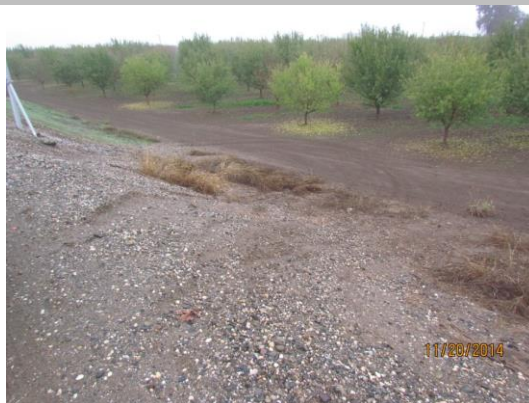
Photo 1 of 2 : SP_2019_MA0005_197_13_20190327_00005.jpg

View of the vehicle erosion along the landside slope.

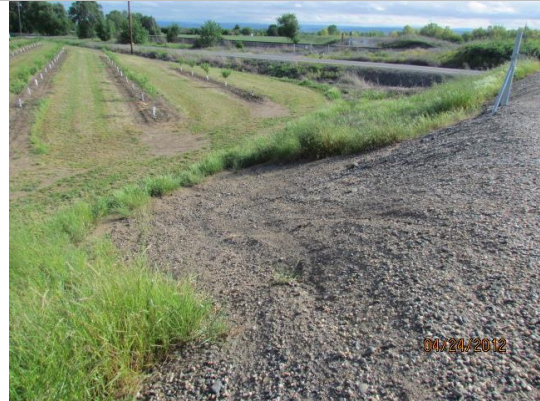
Photo 2 of 2 : SP_2019_MA0005_197_13_20190327_00006.jpg

View of the vehicle erosion along the slope.

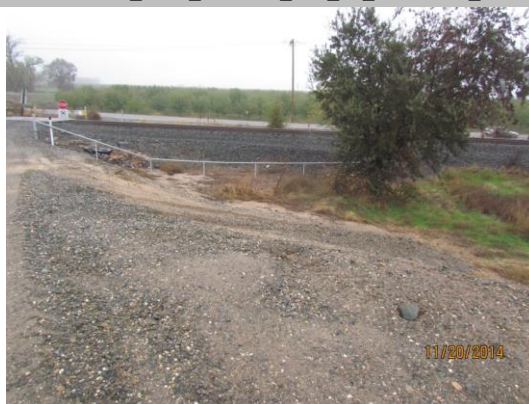
Photo 1 of 1 : SP_2019_MA0005_197_40_20190327_00016.jpg

View of the vehicle slope instability along the landside slope.

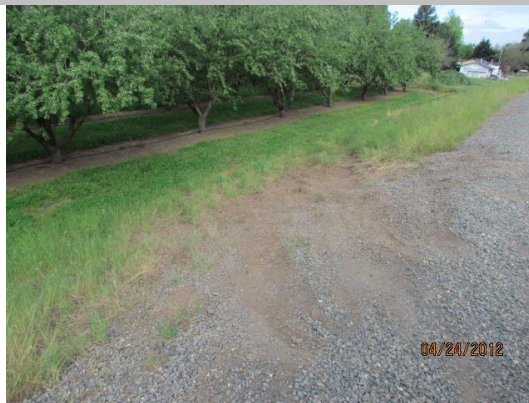
Photo 1 of 1 : SP_2019_MA0005_197_18_20190327_00007.jpg

View of the vehicle erosion along the slope of the levee.

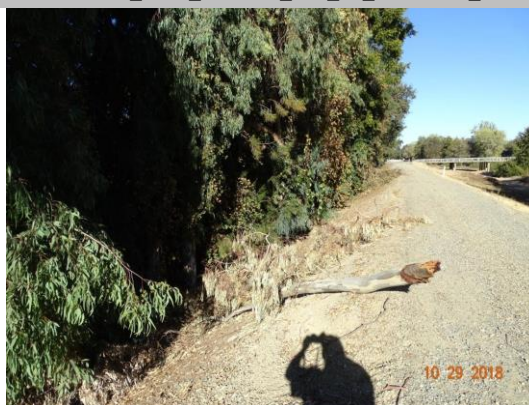
Photo 1 of 1 : SP_2019_MA0005_197_68_20190327_00036.jpg

View of the trees limbs along the landside slope and toe.

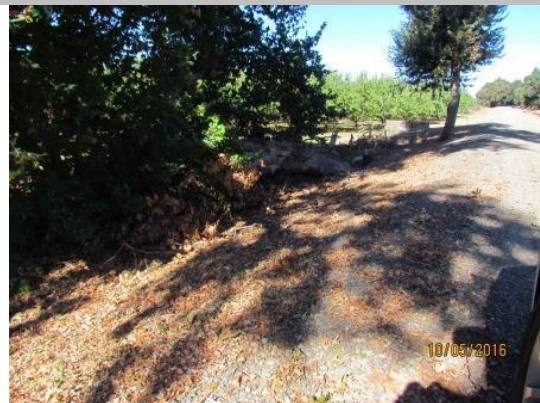
Photo 1 of 1 : SP_2019_MA0005_197_36_20190327_00013.jpg

View of the tree log at the landside toe.

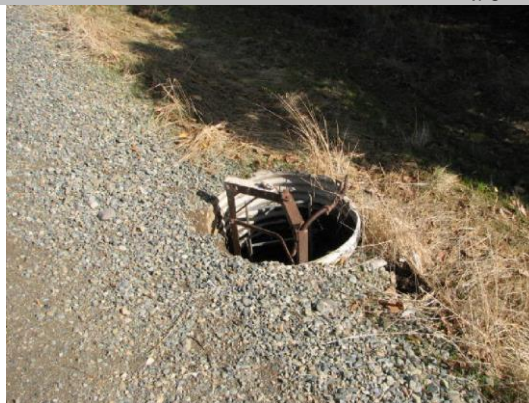
Photo 1 of 3 : UCIP_SP_2019_54048_68465.jpg

Broken slide gate in CM riser on WS slope.

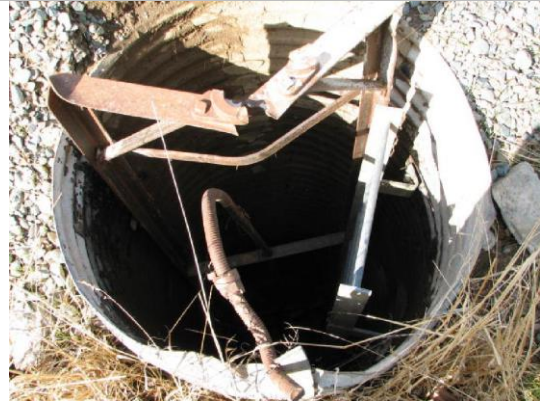
Photo 3 of 3 : UCIP_SP_2019_54048_68463.jpg

Broken slide gate in CM riser on WS slope.

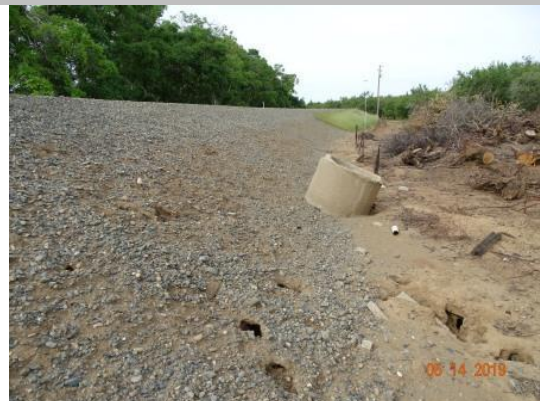
Photo 1 of 1 : SP_2019_MA0005_197_9_20190520_00105.jpg

View of the animal burrows on the landside slope. Spring 2019.

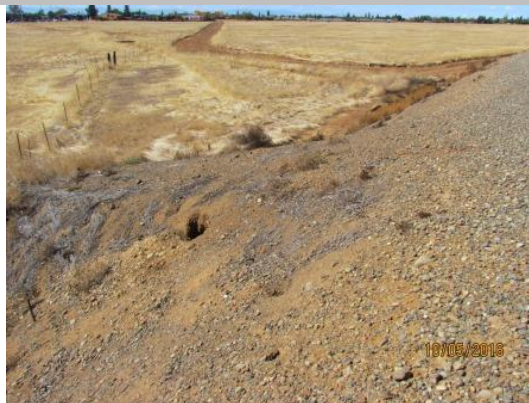
Photo 1 of 1 : SP_2019_MA0005_197_39_20190327_00015.jpg

View of the rodent holes along the landside slope.
